## **TIR GOFAL MANAGEMENT PLAN: HERITAGE MANAGEMENT INFORMATION (HE2)**

**Prepared for:  
Hendre Farm**

**Tir Gofal Reference No  
W/13/4432**

**Cambria Report No. 2005/20**

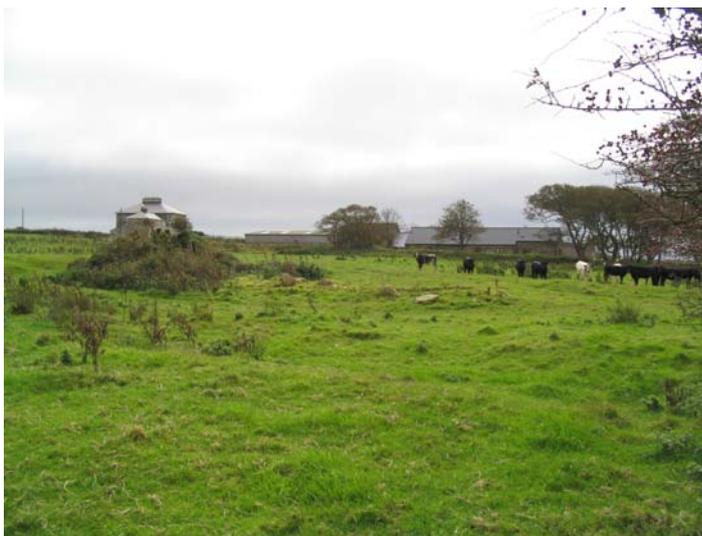
A number of dwellings, field enclosures, and tracks marked on the Tithe Map (1841), but largely gone by the time the 1st Edition Ordnance Survey map was published in 1891. At the time of a field visit in July 1999 despite much vegetation cover, many earthwork features and remnants of stone walls, probable buildings and former paths/ tracks were in evidence which coincide with the tithe map evidence. During the archaeological farm visit, and also during a previous visit by Cambria Archaeology in 1999, the area was very overgrown with thorn and gorse, and this should be addressed.

It has been argued that this deserted settlement site represents post-medieval squatter occupation on the edges of Dowrog Common. However, the remains are quite substantial, and there is place-name evidence to suggest that both Hendre farm and this site were occupied contemporarily (see PRN 51,748). Ludlow and Murphy (2000) have pointed out that in this area of Pembrokeshire, groups of post-medieval farm buildings often occupy the site of a medieval 'vill' or hamlet. This has given rise to the dominant settlement pattern of the area, represented by a high density of small nucleations or hamlets. Ludlow and Murphy also note an unusual arrangement of twinned farms characteristic of the area, which it has been suggested may be a tangible survival of a Welsh custom in which land was held not by individual ownership, but by two persons. It seems just as plausible that Hendre farm and the deserted settlement site were part of one of these twinned farm settlements. If this is the case, this may be a very important site archaeologically, and every effort should be made to protect and preserve the archaeological remains in this area for posterity and possible further investigation.

**Hendre deserted rural settlement (PRN 39,840) with Hendre farm in the background**

During the archaeological farm visit, and also during a previous visit by Cambria Archaeology in 1999, the area was very overgrown with thorn and gorse. Scrub clearance is recommended for this site to enhance visibility. This can be followed by light grazing at times when the ground is stable (ie. not when the ground is waterlogged or very dry).

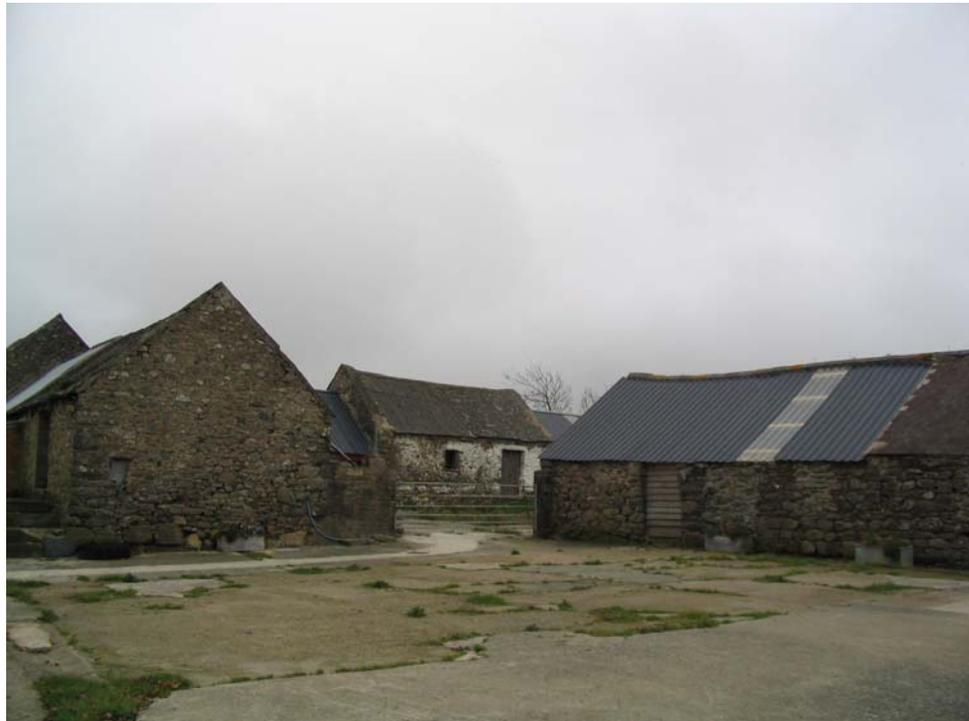
Hendre farmstead consists of a farmhouse, which is said to have been built in 1847 for Watts Williams (PRN 51,749). The farmhouse lies separately, slightly removed from a range of traditional rubble-stone outbuildings (PRN 51,750). The new farmhouse replaced an earlier one, which stood further west, probably in the area that the outbuildings still occupy. The archaeological potential of the area around the present Hendre farmstead is very high. The construction of the new farmhouse post-dates the parish tithe map for St. David's (1840-1) by about six years. However, the tithe map does not make it clear where on the site the earlier farmhouse lay. Various historic maps from the earlier nineteenth century show groups of buildings in the area of the present outbuildings, and to the north (the deserted rural settlement PRN 39,840). It is possible that the outbuildings actually incorporate at least parts of the former farmhouse within the fabric of

the current range. It is likely however, that there are below ground remains of earlier buildings in the vicinity of the farmstead. The western end of the farmstead occupies an area which may represent an earlier settlement site. Not only does the name 'Hendre' point to this possibility, but there is a field name which suggests that Hendre itself and the deserted settlement to the north were once occupied contemporarily, forming a small nucleated settlement. The meaning of 'Llain rhwng y ddwy dre' (the name given in the tithe apportionment to field north of the outbuildings) is literally 'blade between the two settlements/ townships'. Historic map evidence demonstrates that the settlement to the north had been abandoned by the mid nineteenth century, while Hendre itself has seen continued occupation.

**Part of the range of outbuildings at Hendre viewed from the north-west**

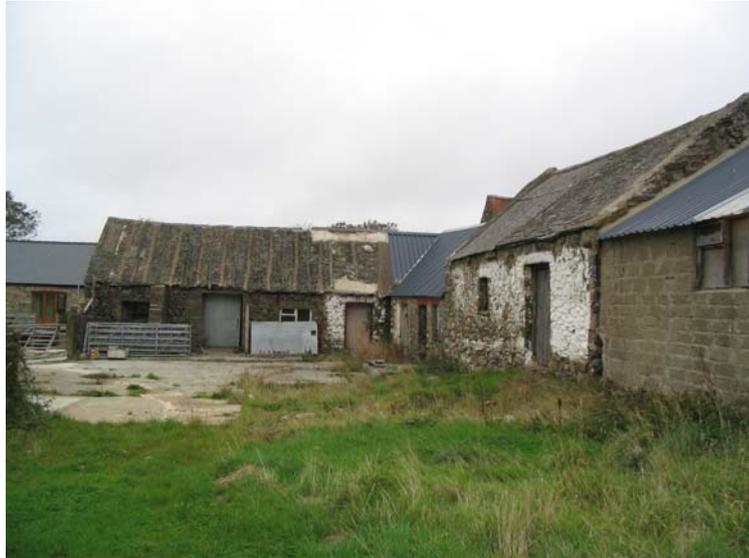
of buildings, meeting at a right angle. The south elevation had become unsound in the past and is now supported by some make-shift buttresses. Attached to the east end of the row described above is the only two-storey outbuilding in the range. It is constructed of rubble stone, with access to the second storey gained via an external set of stone steps on the eastern gable-end. The front elevation faces north, and comprises a window opening (now bricked up) and door to the ground floor, and a window opening (with louvred panelling) and ventilation slit to the first storey. This probably represents a stable. Three buildings form the east side of the yard. These are all rubble built, with lime mortar between the joints and lime wash in evidence in some locations. There are variations in roof height: the central building in the row has a higher roof line, and consequently the roofs on the two buildings either side are butted up to this building. The two southerly buildings in the row have distinctive upstanding rubble-stone copings at the gable ends.

**The three buildings forming the east side of the yard, showing lime wash on the central building, and east-west barn range in the background, with 'ribbed' pointing on the roof slates**

There is evidence that lime-mortar and lime-wash were the materials used to weatherproof these buildings, and ideally these should be used in any repair work carried out.

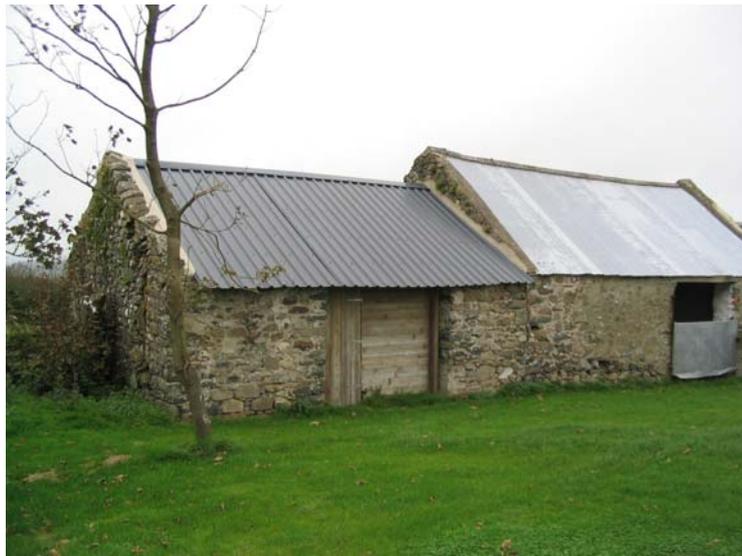
The extreme southern gable-end is deteriorating rapidly: it is bulging outwards, with lime mortar crumbling from the joints. It appears that the western elevation of this building has suffered from collapse, as it has been replaced by concrete breeze-blocks.

**The rear of the row seen above, showing deterioration of the southern gable-end**

The extreme southern gable-end is deteriorating rapidly: it is bulging outwards, with lime mortar crumbling from the joints. This needs to be stabilised.

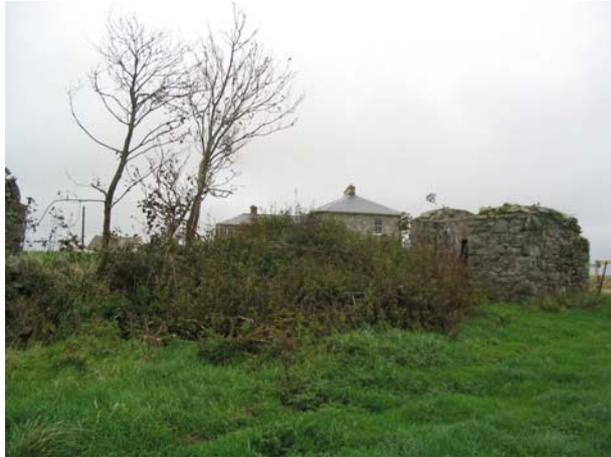
that the original roofing material was slate with a mortar coating. However, in this context there is a historical precedent for corrugated iron, and this would be the preferred option for cheaply ensuring that the buildings remain weatherproof. To the south-east of the main barn range, but clearly associated is a small square stone building with very thick walls. There is a door opening with wooden lintel on the north-west elevation. There is no remaining roof structure, but the tops of the walls give the impression that the building may have been higher previously. The building appears on the more detailed maps of the later nineteenth century, although its' function is unknown.

**Small square stone building viewed from west**
